Silver and Baryte North America Hurricane Ivan Encounter

Silver & Baryte (S & B) Industrial Minerals, North America, Inc. imports minerals for distribution in the eastern United States. Early in 2002 S & B approached Rubb about their need to build a bulk storage facility for perlite in the Theodore (Mobile) Alabama area.

Rubb proposed and subsequently built a 130' x 433' (56,333 ft²) BVE Range Rubb building at the port facility in Theodore. The building was designed to code which required the design to withstand sustained winds of 110 mph (130 mph 3-second gusts) and a live roof load of 12 psf.

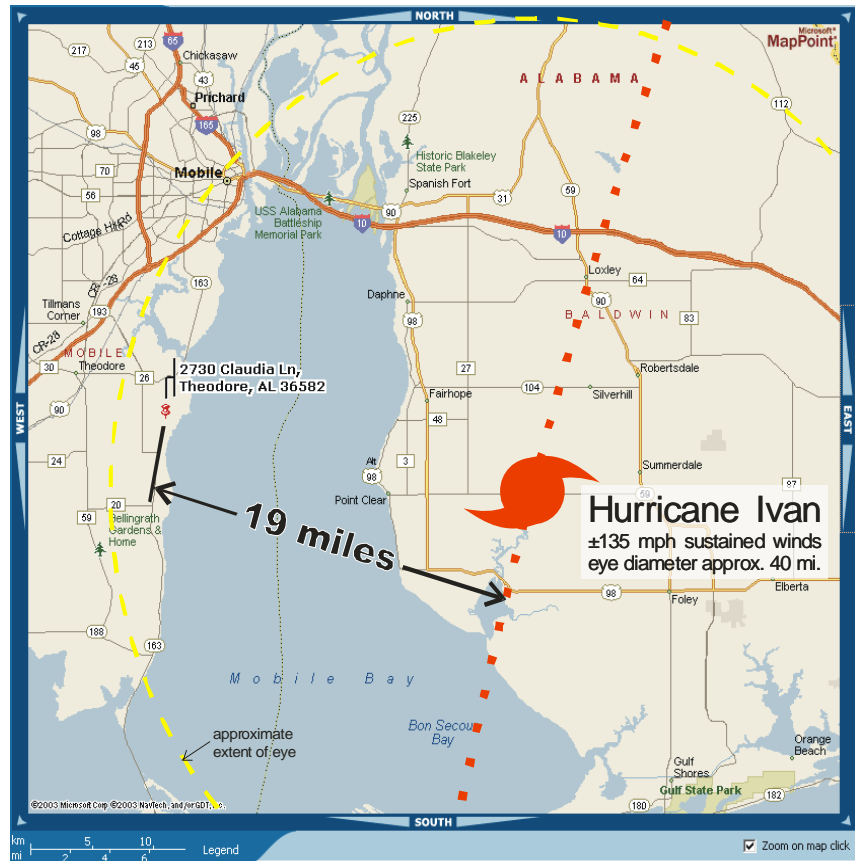
Map source: Microsoft MapPoint
Data source: <http://www.nhc.noaa.gov>

The track of the hurricane (see map) moved inland up the eastern shore of Mobile Bay and subjected the Rubb building to sustained winds 30 mph higher than the design wind speed. As the hurricane moved inland and people were able to return to the site they found the Rubb building intact and the perlite dry. The entire area surrounding the warehouse was heavily damaged.

In September of 2004 the two year old structure was subjected to the fury of Hurricane Ivan. The hurricane with sustained winds of +135 mph came ashore from the Gulf of Mexico at Gulf Shores, Alabama; just across Mobile Bay from S & B's Rubb warehouse.

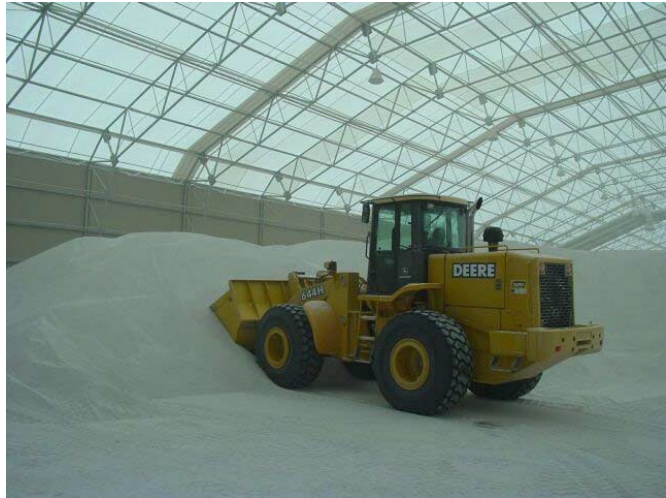
According to Core Industries, which is our local stevedoring subcontractor, there are some minor leakings below the warehouse doors, especially at the east side, that eventually did not affect the quality of the material as it was stock piled more to the middle center of the space.

Structural wise the warehouse seems to be intact and no leakings from the roof or the sides were recorded.
